February 2007 Monthly Report for the Falls Creek Hydro-electric Project  
FERC # P-11659

**Falls Creek Hydroelectric Project (P-11659)**  
**MONTHLY CONSTRUCTION REPORT TO FERC**  
**February 2007**

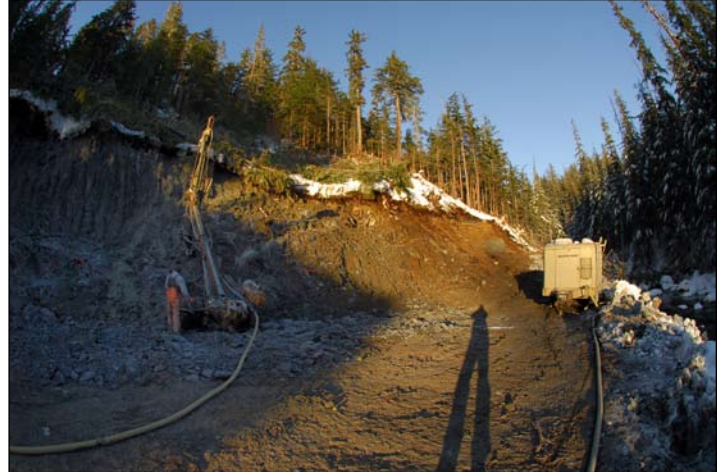
*Drilling at the Intake site.*

Drilling at the intake area was successful and created no slides or sedimentation of the creek.

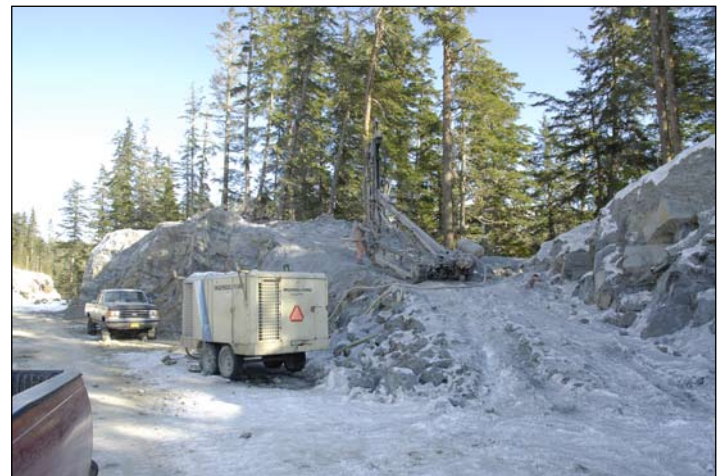
The rock pit in the Blueberry Hill area was drilled during the last week of the month and will be shot early in March. This rock will be for future penstock cover and for rip rap.

*Drilling at Blueberry Hill.*

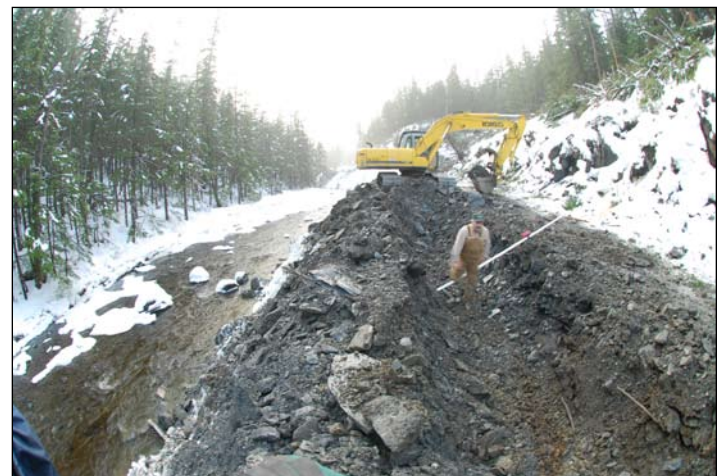
Work on digging the final grade of the penstock trench started on the intake road, but was soon halted due to frozen ground. The material is shot rock, but there was just enough muck mixed in to cement the rock in places. The gravel pit is also frozen and covered in deep snow, so bedding and backfill for the pipe are also not available until spring.

*Ditch preparation for the HDPE pipe began in February. This work was stopped by frozen ground.*

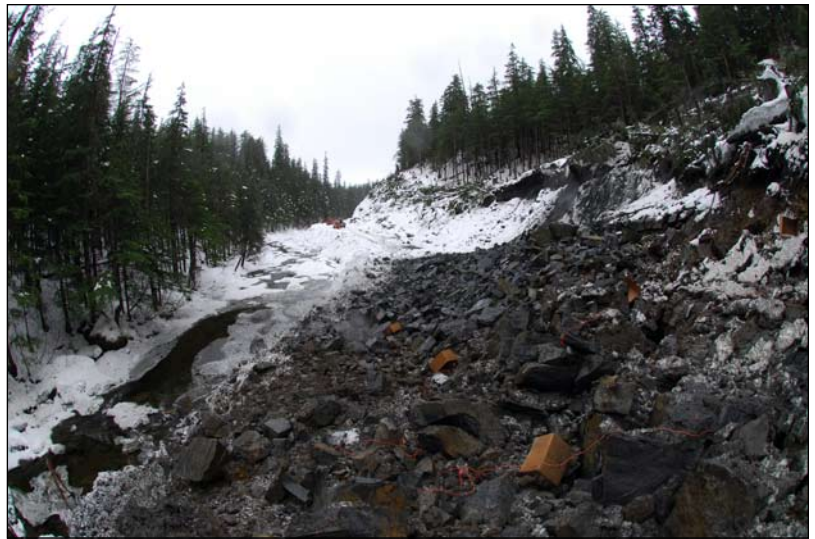
*Successful shot at the Intake site.*

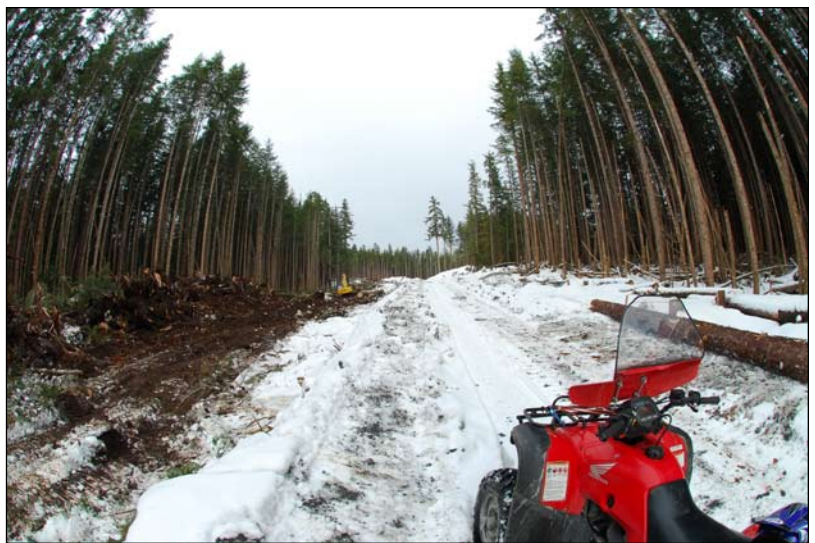
The clearing width from the gravel pit to the powerhouse site was increased from ~60 feet to ~150 feet. Approximately 20 potential murrelet trees were removed in this effort. A Record of Concern was submitted to the project manager because the ECM wanted a documented explanation for why the murrelet trees were taken given that they had been

*View of the expanded clearing width just down from the gravel pit. Note the spoils berm along the forest edge (at left) intended to protect the pipe from falling trees.*

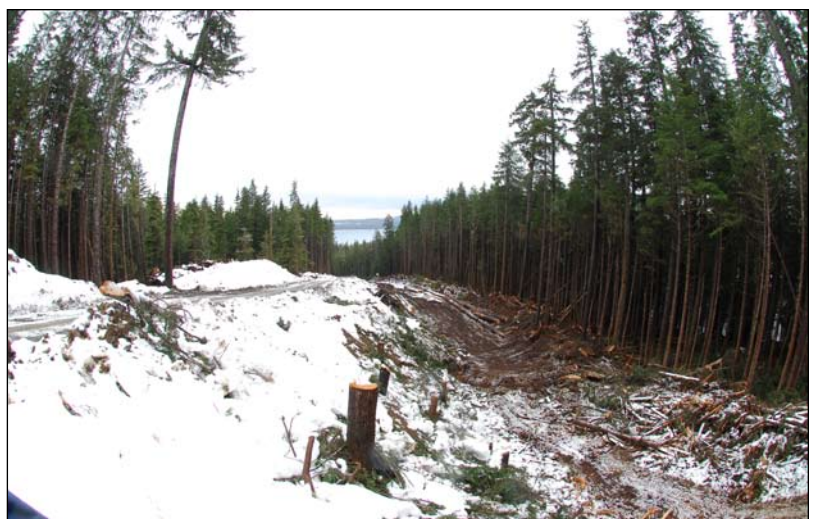
*Another view of the expanded clearing width. Trees removed from here were flagged as murrelet leave trees in April of 2006.*

identified as leave trees several months earlier and because there is nothing in any of the plans that describes a situation in which a 150 foot clearing width would be necessary. This report was submitted to FERC and other relevant agencies, including a Record of Response from the project manager, at the end of the month. Please see this document for additional details (available at [www.gustavuselectric.com](http://www.gustavuselectric.com)).

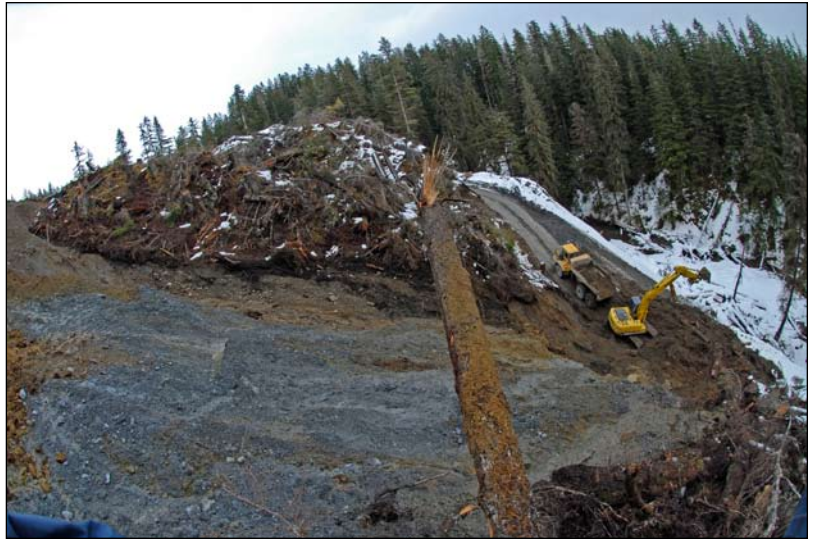
*Looking down toward the powerhouse access road. The stripped section of the hill was cleared to reduce the likelihood of mass wasting and to prepare the ground for eventual penstock anchoring..*

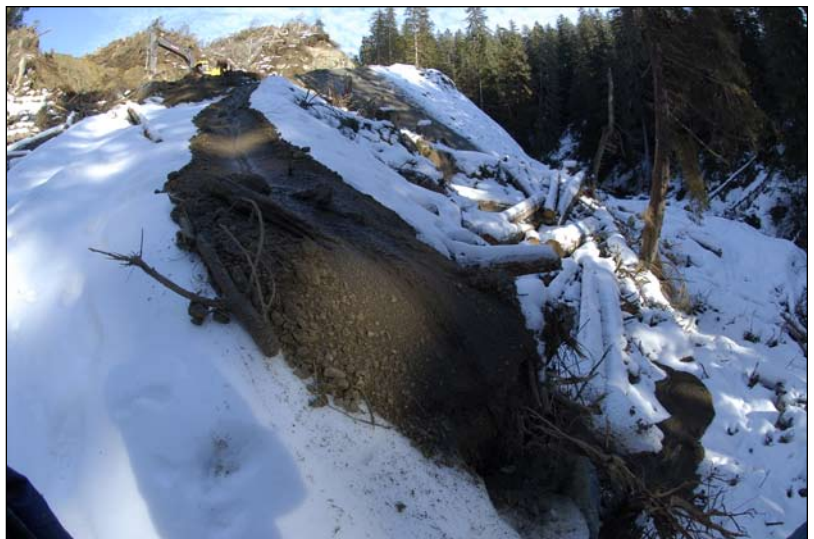
Stripping of topsoil for the steel penstock alignment has emphasized the need for fairly aggressive sediment and erosion control measures to be in place by the spring thaw. This was also covered in the February 19th Record of Concern.

*Sediment running down hill from work on the approach to the Powerhouse. This area will require fairly aggressive sediment and erosion control measures to avoid sedimentation of Falls Creek.*
